PAST Comes to Walnut Canyon National Monument

In September 1994, Flagstaff Area Parks (Flagstaff, AZ.) was faced with extensive repairs on the two historic Civilian Conservation Corps (CCC) rustic houses at Walnut Canyon National Monument. The park took an unprecedented step of turning the project into training. Roofing deterioration, unsightly accretions to the buildings, masonry failures, structural deficiencies, and peeling paint were among the litany of itemized deferred maintenance tasks waiting for funding. Recently added to the NPS List of Classified Structures, these two stone, timber, and frame houses represent some of the best of what the Park Service assembled for staff lodging during the depression era.

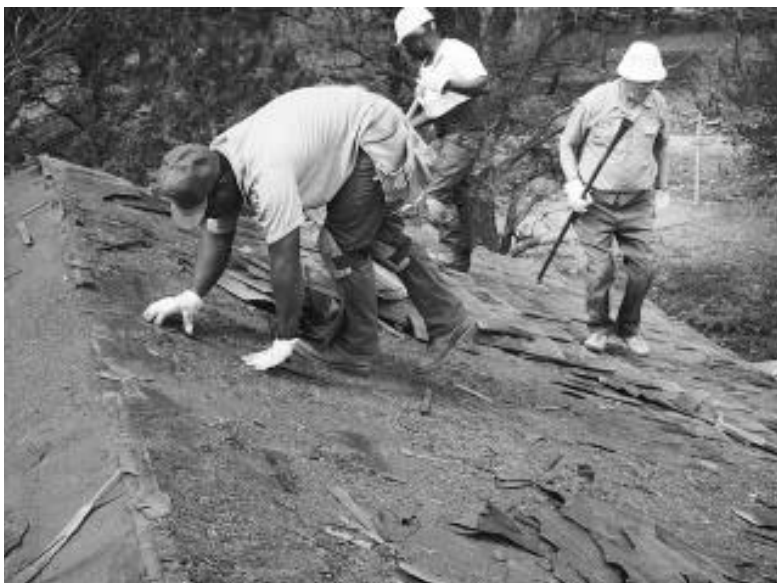
PAST program participants tear off roof at Residence No. 1.

In 1993, the need to replace the roofing on the two structures HB-1 and HB-2 was well recognized. The harsh environment in Flagstaff had not been gentle on the cedar shakes. They were extremely deteriorated (desiccated, cracking, eroded, and loose) and deficiencies were noted in the chimneys, gutters, and trim. Both houses had nonhistoric garages constructed with flat built up roofs that were leaking. These flat roofs were unsympathetic to the character-defining quality of

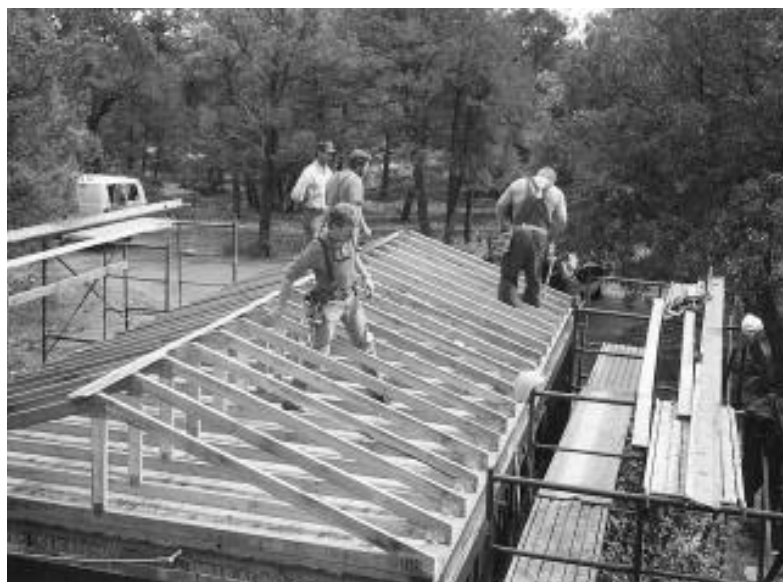
Work in progress: new roof framing system being installed. Photo by Christina Armijo.

In the five days of actual hands-on work sessions, considerable accomplishments were realized. Twenty-seven individuals were organized and provided with tools and supplies to carry out pre-planned tasks. Pitched roofs at 4:12 were built on both garages, including finished gable ends. Old roofing shingles were demolished, debris was hauled away, and approximately 4,000 square feet of cedar shake roof was installed. Custom roof vents were built on site. Custom supplemental trusses were built on site. Deteriorated sandstone was replaced on porch patio areas. Board and batten was restored on gable ends of both houses replacing non-historic shingling. Rotten sections in old garage decking, support members, trim, gutter boards, and raker boards were repaired and replaced. Two chimneys were reflashed, repointed, and had new caps built. Glulam beams were installed to DSC engineer specifications in residence #2. (Residence #1 beams were installed later). Structures were primed and painted. Classroom training was accomplished. Planing and preparations turned what could have been months of work into five fast-moving efficient days. The weather cooperated and not one minute of time was lost.

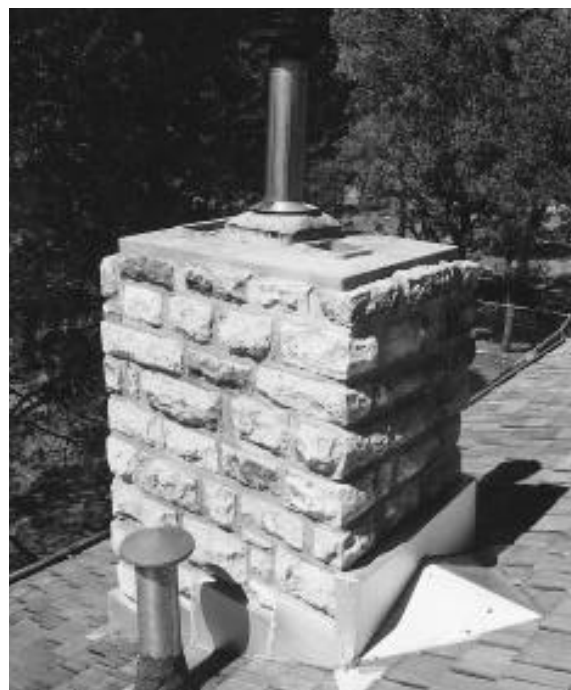
Attention to detail: completed chimney has been re-pointed and re-flashed. Photo by Pam Meck.
